# AN EXPERIMENTAL STUDY ON THE WEAR BEHAVIOR OF WATER-LUBRICATED ACM COMPOSITE BEARINGS AND PROPELLER SHAFT SYSTEMS UNDER SAND AND SEDIMENT IN LUBRICATING WATER

TRUONG TIEN PHAT\*, BUI THI HANG

Faculty of Marine Engineering, Vietnam Maritime University

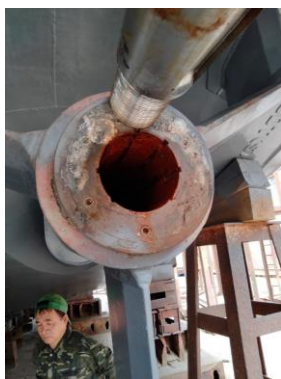
Vessel 3 (PTSC 05 tugboat, 5 years, Nghi Son port): Average clearance 1.25mm (design 0.60mm; limit 4.0mm). Bearing surface showed acceptable moderate wear; shaft sleeve (AISI 421)  $Ra=1.2\mu$ m with no abrasive grooving (Figure 2).

**Figure 2. Vessel 3 (PTSC 05 tugboat) after 5 years, Nghi Son port: bearing bore - moderate uniform wear; AISI 421 shaft - no abrasive damage**

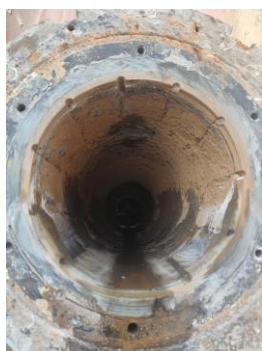
Vessel 7 (Lucky Star rice carrier, 3 years): Cooling-water passages found partially blocked by silt accumulation, reducing coolant flow to below 40% of design value. Bearing Ra measured 4.8 $\mu$ m; diametral clearance 8.42mm - exceeding the 6.0mm allowable limit (Figure 4).

**Figure 4. Vessel 7 (Lucky Star rice carrier) after 3 years: The cooling-water grooves were partially blocked by silt deposits due to silt buildup, diametral clearance 8.42 mm - exceeding the 6.0 mm allowable**

Flow blockages caused by mud (Lucky Star, Thai Binh, Hai Duong) gradually clogged the bearing coolant channels and water supply lines, causing hydrodynamic lubrication film collapse and a shift from full-film lubrication to mixed/ boundary lubrication. This mechanism may occur even in the absence of coarse sand particles and requires remediation by regular flushing.

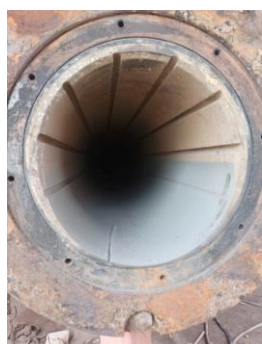
Vessel 8 (Viet Thuan coal carrier, 2 years, Tra Vinh river mouth, TSS 380-520 mg/L): Pronounced longitudinal abrasive grooving on all three bearing segments - groove depth 35-70  $\mu\text{m}$ , width 120-250  $\mu\text{m}$ . Diametral clearance 10.68mm (limit: 6.0mm); shaft sleeve  $Ra$  3.9 $\mu\text{m}$  (Figure 5).

**Figure 5. Vessel 8 (Viet Thuan, Tra Vinh river) after 2 years: Severe three-body abrasive grooving across all three bearing stave sections caused by sand ingress from unfiltered cooling water (TSS 380-520**

Three-body abrasive groove wear was the dominant mechanism in Group C. Sand particles ( $\text{SiO}_2$ , Mohs 7) entered the bearing gap, which was 3-4 times harder than the ACM surface, creating micro-cut grooves parallel to the axis of rotation. Groove depth correlated with particle size and concentration; the 100-250  $\mu\text{m}$  range caused the most damage, consistent with the  $K_{\text{env}}$  prediction from equation (2). This size range is characteristic of Vietnamese riverbed sand [6].

Fit a self-cleaning two-stage strainer on the bearing cooling-water supply: Stage 1 (200 $\mu\text{m}$ ) removes coarse debris; Stage 2 (50 $\mu\text{m}$ ) removes the most damaging fine-medium sand fraction. This reduces particle ingress by 80-90% and is estimated to extend bearing life by 2.5-3.5×. Installation cost ~VND 15-25 million/vessel is recovered within one avoided unscheduled drydock.

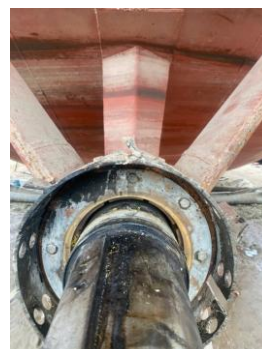
Vessel 9 (Hai Duong sand dredger, 2 years): Operating directly in the dredging zone (TSS estimated 600-1200 mg/L). A net-fouling incident damaged the propeller, causing shaft imbalance. Bearing clearance 12.1 mm after 2 years; delamination failure with detached composite fragments in 3 of 4 staves; surface crack on shaft sleeve in aft bearing zone (Figure 6).

**Figure 6. Vessel 9 (Hai Duong sand dredger) after 2 years: Bearing bore with delamination failure and embedded sand debris; shaft sleeve with deep longitudinal scratching and pitting**

Surface spalling was observed on the bearings of the Hai Duong dredger, indicating that cyclic impact

loads from dense sand and mud created subsurface cracks at the fabric-resin interface, eventually spalling the composite pieces. This mode occurred after the wear limit had been exceeded.

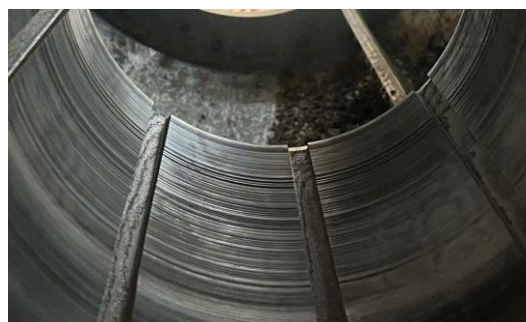
Vessel 10 (Thai Binh power-station cooling pump, 6 months): Bearing failed after only 6 months. Shaft runout measured at 0.18mm prior to installation (allowable:  $\leq 0.05\text{mm}$ ). Combined with Thai Binh river water (TSS  $\sim 450\text{mg/L}$ ), this produced asymmetric loading and highly non-uniform wear

(1.6mm on loaded side vs. 0.5mm opposite). Silt deposition was found blocking 40% of the cooling-water inlet cross-section (Figure 7).

**Figure 7. Vessel 10 (Thai Binh power-station pump) after 6 months: Sand and silt deposits blocking cooling-water passages and bearing housing. Shaft runout 0.18mm (3.6 $\times$  allowable) combined with high TSS produced asymmetric premature failure**

The Thai Binh pump case demonstrates that installation defects are independent root causes. Shaft runout of 0.18 mm ( $3.6\times$  allowable) introduced an alternating bending moment producing the characteristic asymmetric wear observed. This finding is particularly relevant to the Vietnamese inland vessel fleet, where shaft machining is often contracted to small workshops without rigorous dimensional verification. Runout measurement and correction must be treated as mandatory - not optional - pre-installation steps.

Mandatory shaft journal runout measurement ( $allowable \leq 0.05mm$ ) and bearing housing alignment check prior to bearing installation. Any runout exceeding tolerance must be corrected by journal re-grinding. Verify cooling-water passage cross-sections for freedom from silt deposition.
